Subject: Updated Restoration Plan for California Coastal Commission

Enclosed, please find the combined Restoration Plan and Remedial Grading Plan for the Temescal Ridge Pole Replacement Project. The plan has been modified, based on comment provided by the California Coastal Commission on June 6, 2024, to describe the straw wattles being used as sterile instead of weed-free and to remove all references of berm restoration. Portions of the plan that referenced berm restoration were updated to reflect the current plan of berm removal and straw wattle placement as needed.

Updated Temescal Ridge Pole Replacement Project Resource Management Plan

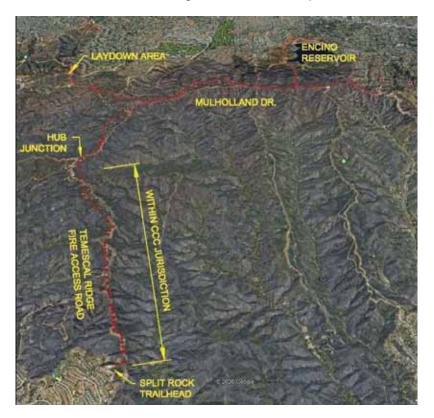
Figure 2 Site Map

A portion of the Temescal Fire Road between Split Rock Trailhead and Hub Junction lies within the jurisdiction of the CCC. See Figure 2 for site map.

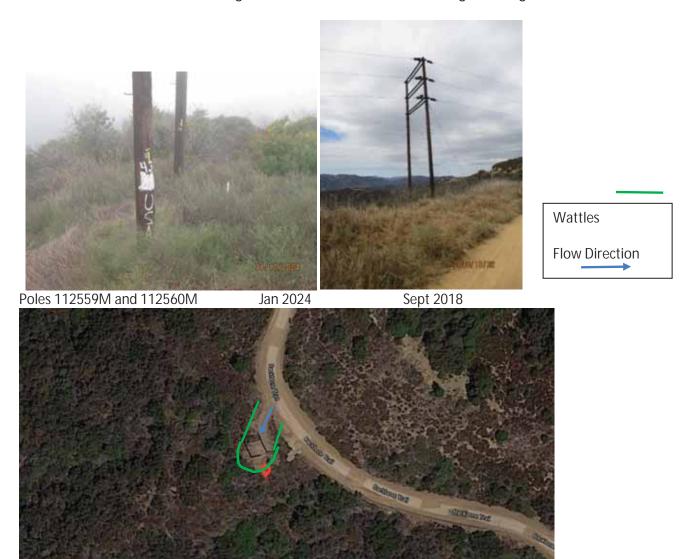
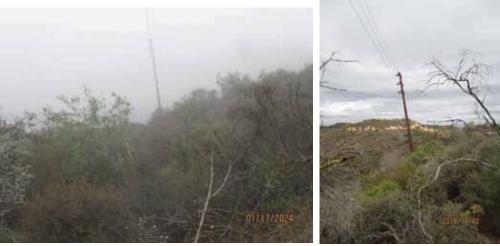
Pole 112561M

Previous access disturbance is fully revegetated. No additional disturbance or earthwork to be performed. Access will be by foot only.

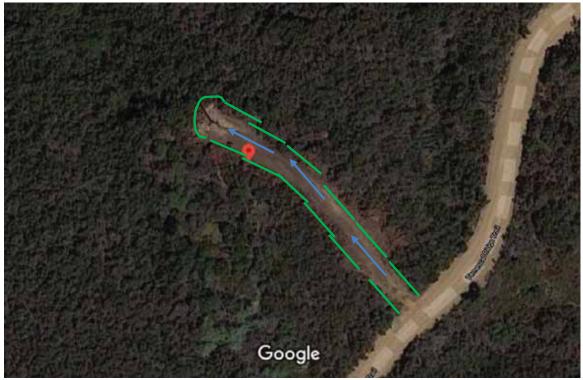
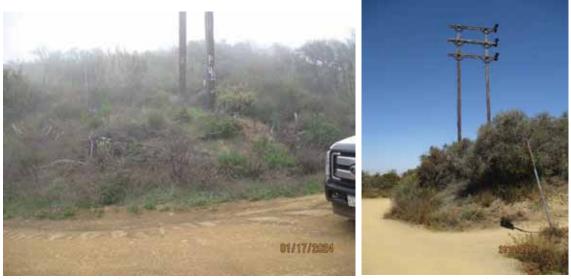
Poles 112564M and 112565M

Previous access disturbance is fully revegetated. No additional disturbance or earthwork to be performed. Access will be by foot only.

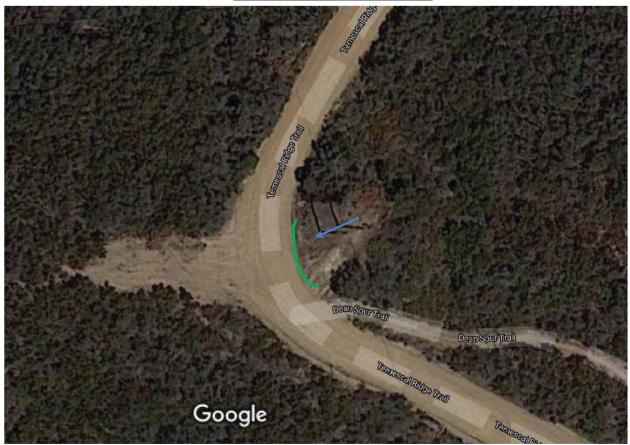
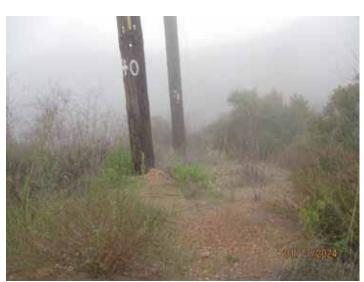
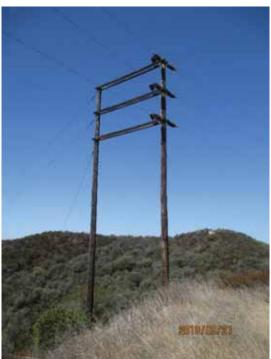
Poles 112566M and 112567M

Previous access disturbance is fully revegetated. No additional disturbance or earthwork to be performed. Access will be by foot only.

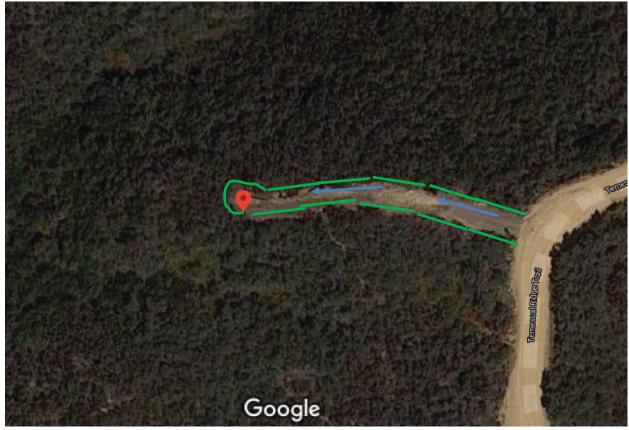
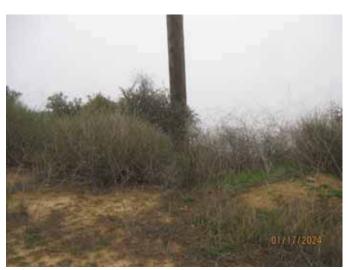
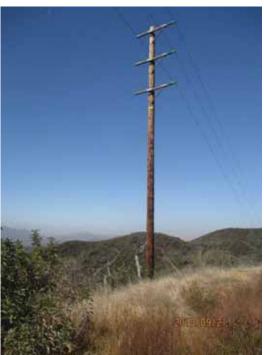
Pole 417080M Jan 2024 Sept 2018

Previous access disturbance is fully revegetated. No additional disturbance or earthwork to be performed. Access will be by foot only.

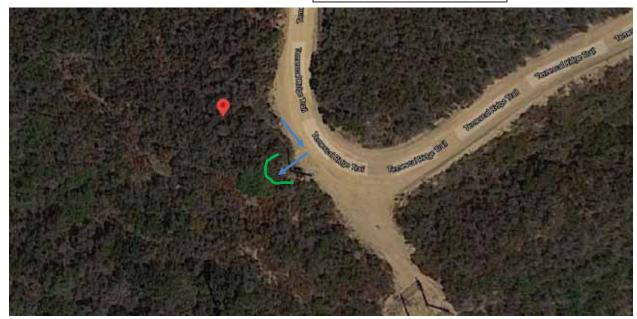
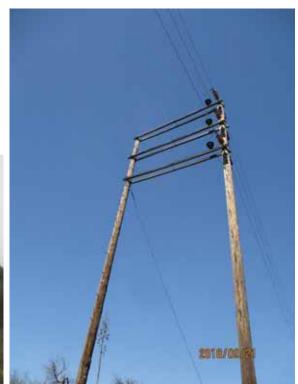
Poles 112573M and 112574M

Access from main road. No earthwork performed previously, none anticipated.

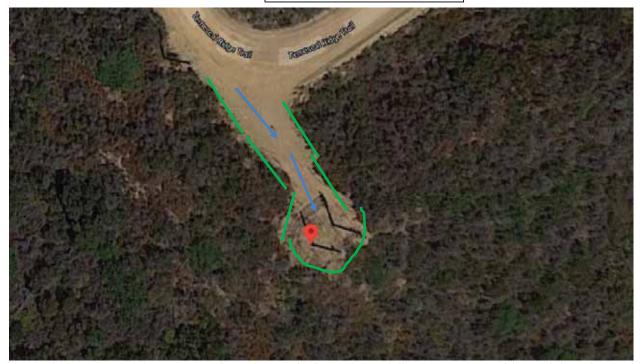
Access is from an existing turnout along the road. The area has fully regrown. No additional disturbance or earthwork will be necessary. Foot access only to replace the pole from the turnout.

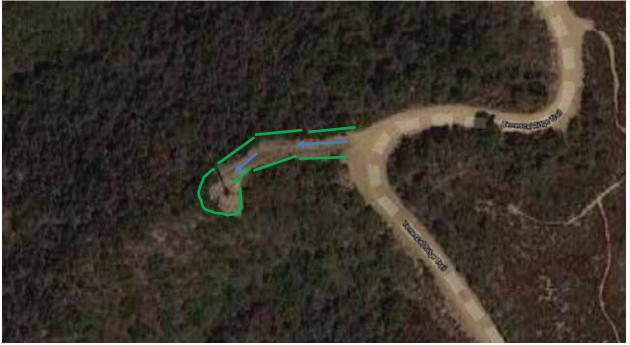
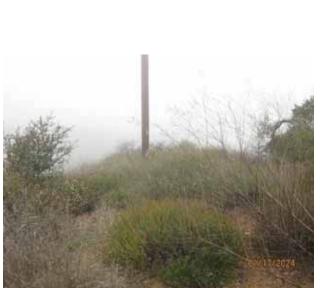
Pole 417081M

This location the berm was breached and the path cleared to the pole. The access is fully revegetated and will not be disturbed further. Access will be by foot only. The berm will be removed. Area will continue to revegetate.

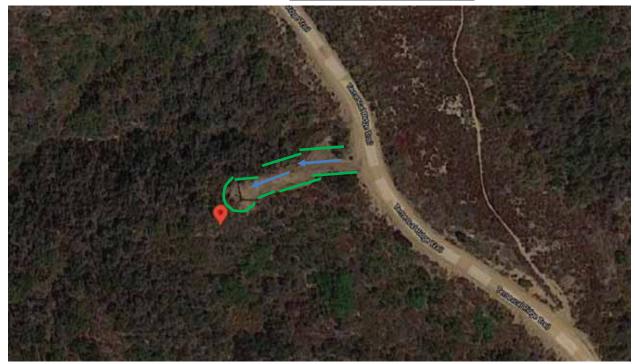
Access to pole has fully regrown. No additional clearance or earthwork to be performed. Access by foot traffic only to replace the pole.

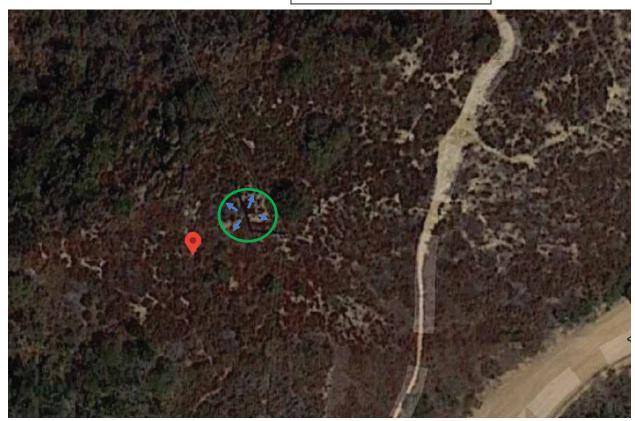
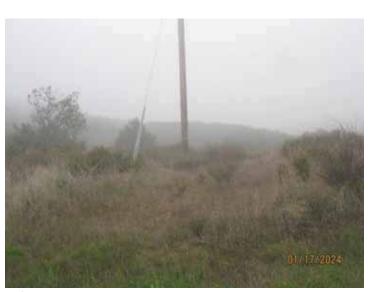
Pole 404104M Jan 2014 Sept 2018

Access is from an existing single track bike path. Area is fully vegetated. No additional clearance or disturbance necessary. Access will be by foot only.

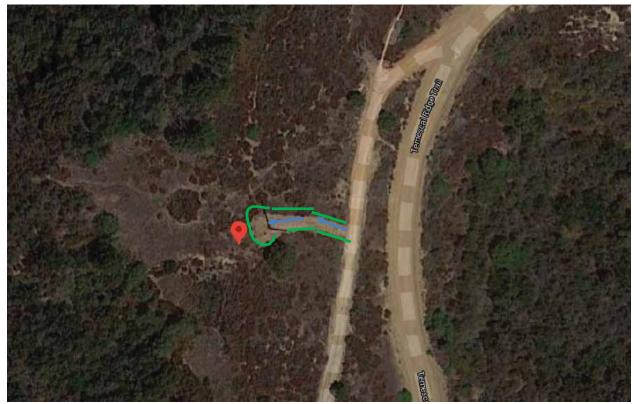
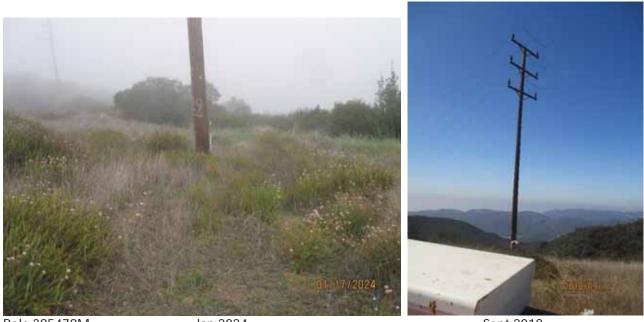
Pole 395479M Jan 2024 Sept 2018

Access from an existing side road. Any evidence of prior vegetation clearing or earthwork is not visible and not additional earthwork will be performed. Access by foot only.

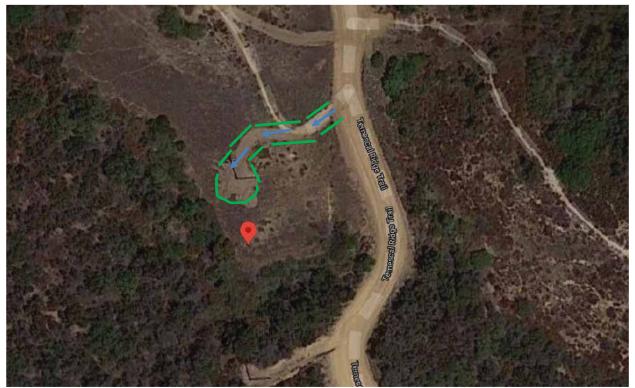
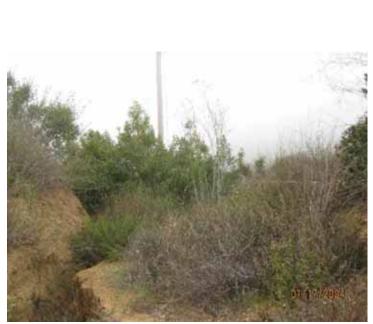
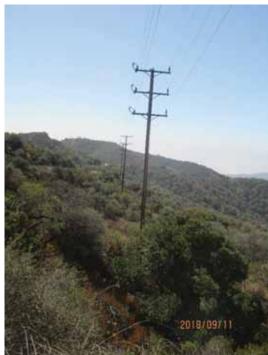
Pole 395480M Jan 2024 Sept 2018

Access is off of an existing single track bike path. Any disturbance to the pole has regrown since the initial disturbance. No additional disturbance or earthwork will be performed. Access by foot only.

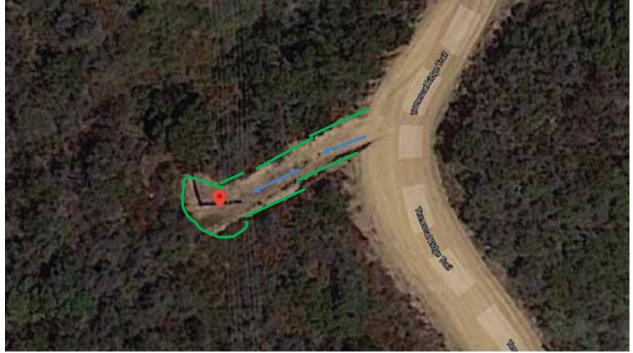
Access to this pole was achieved by breaching the exiting roadway berm. The area has regrown since the initial disturbance and is fully revegetated around the pole. This site does show some hillside erosion from flow coming off the roadway and will be repaired. 2-3 cubic yards to repair the erosional scar, the berm will be removed.

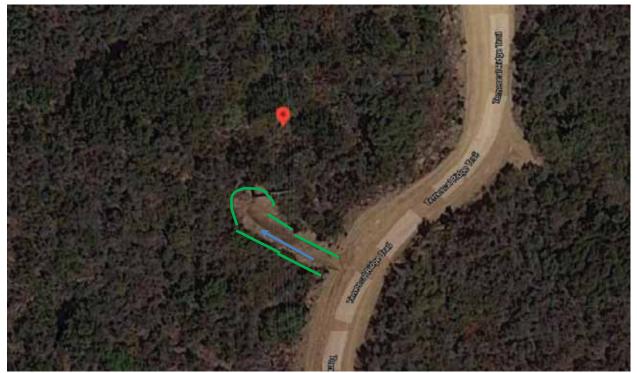
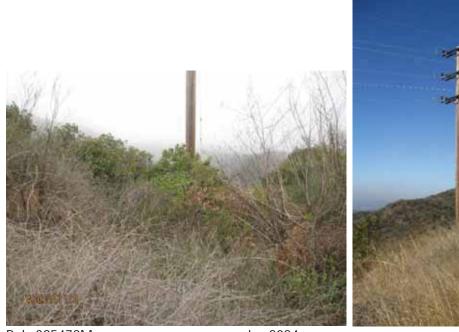
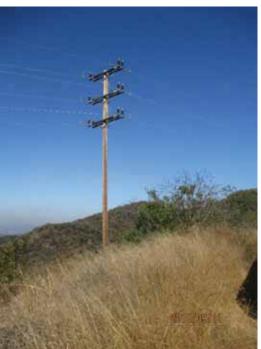
Pole 395478M Jan 2024 Sept 2018

Access created to this tower has fully regrown and will not be further disturbed. Access will be accomplished by foot only. Area will be allowed to continue revegetation. No additional earthwork.

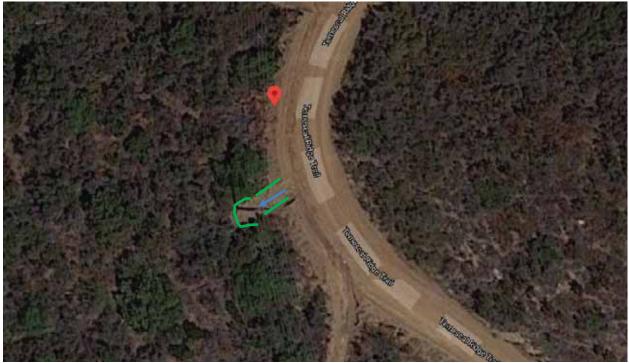
Access to this pole was achieved by breaching the exiting roadway berm. The area has regrown since the initial disturbance and is fully revegetated around the pole. This site does show some hillside erosion from flow coming off the roadway and will be repaired. 2-3 cubic yards to repair the erosional scar, and the berm will be removed.

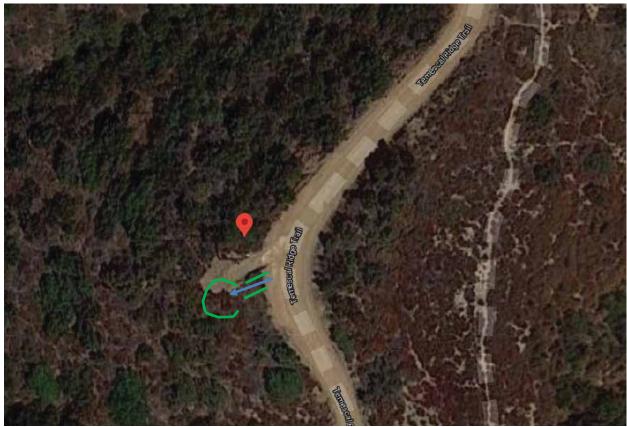
Pole 384797M Jan 2024 Sept 2018

Access to this pole was achieved by breaching the exiting roadway berm. The area has regrown since the initial disturbance and is fully revegetated around the pole. This site does show some hillside erosion from flow coming off the roadway and will be repaired. 2-3 cubic yards to repair the erosional scar, and the berm will be removed.

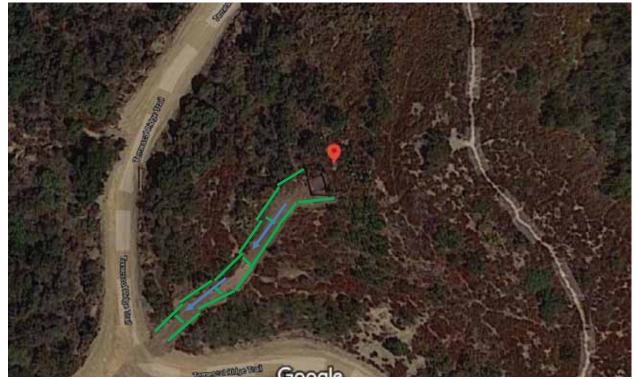
Poles 384790M and 384791M

Any previously cleared access has regrown. No new clearance will be performed and no additional earthwork as it would cause more damage. Access will be by foot to replace pole.

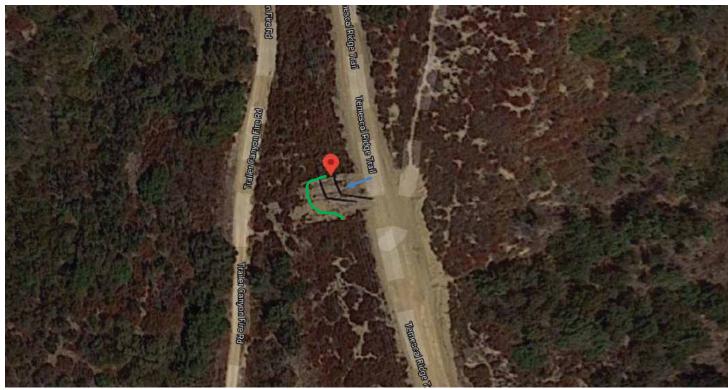
Access from main road. Cleared area has regrown. No clearing or additional earthwork anticipated at this location.

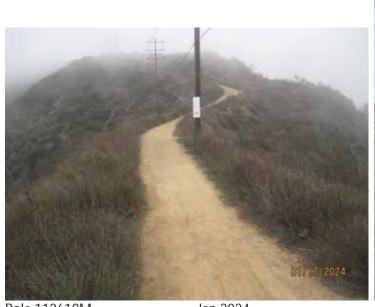
Pole 112610M Jan 2024 Sept 2018

Access to pole is from the main access road. No additional earthwork anticipated.

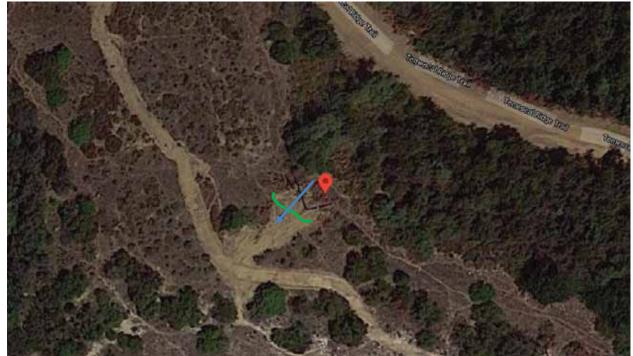
Pole 112613M

Small access path is currently visible at the site, area will be allowed to further regrow after pole replacement. No additional earthwork anticipated at this location.

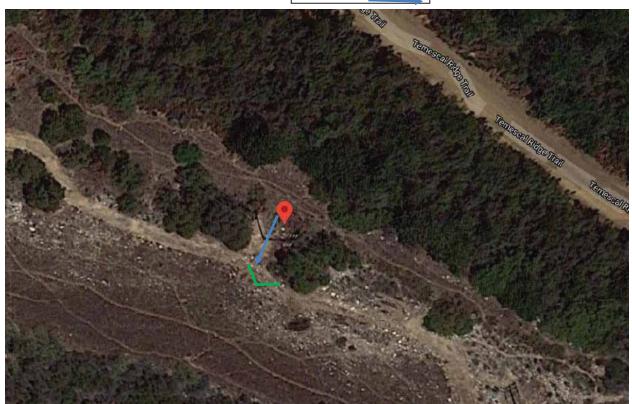
Pole sits along a single track bike path. Some brush clearance may have been done, no additional clearance or earthwork necessary. Area will be allowed to regrow after pole replacement.

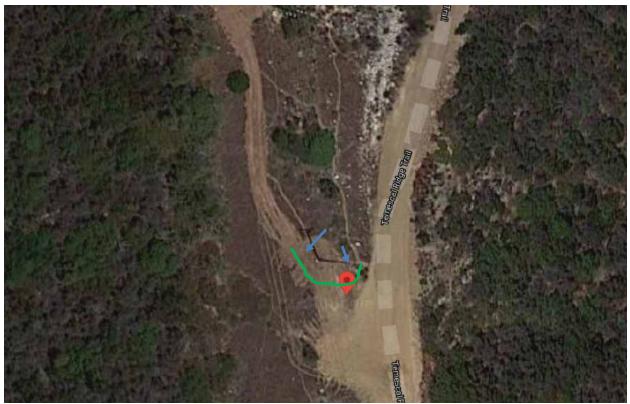
Pole is accessed from the main road and sits along an active single track bike path. No earthwork performed previously and no new earthwork anticipated. Area has regrown and will not be cleared.

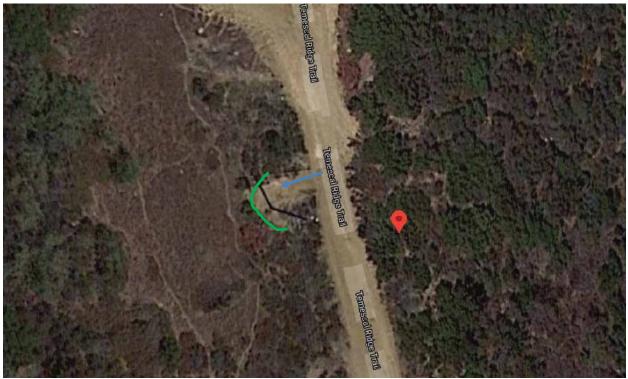
Slight footpath visible in current photo. Access from main road, no earth work performed, none anticipated. Area will be allowed to revegetate.

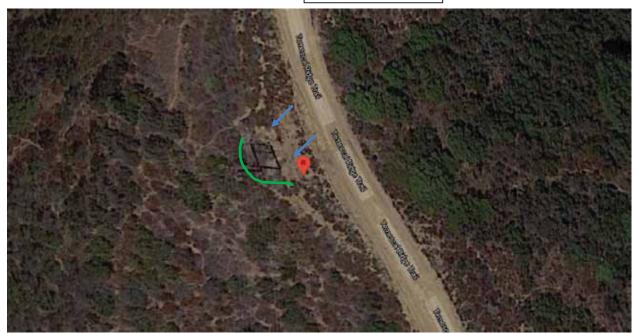
Access is off of the main fire road. No earthwork performed prior and none expected. Area around pole will be allowed to revegetate

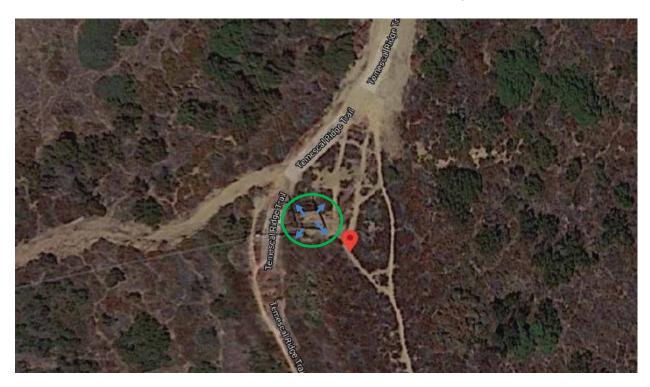
This pole sits atop a small knoll and is located in an active bike path area. No earthwork was performed and no additional work is anticipated for the pole replacement.

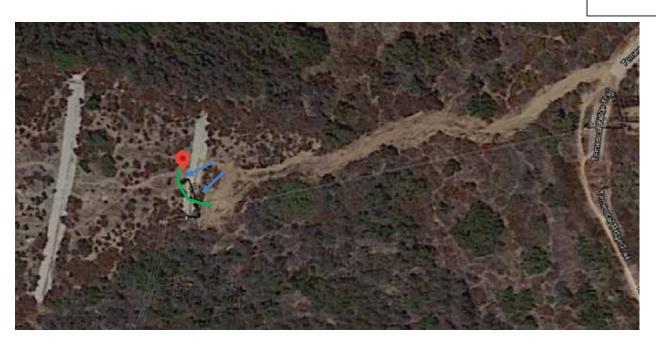
Pole 356250M Jan 2024

No trail access is visible in the January 2024 photo. Cleared area has regrown. No earthwork anticipated at this location, no earthwork restoration proposed.

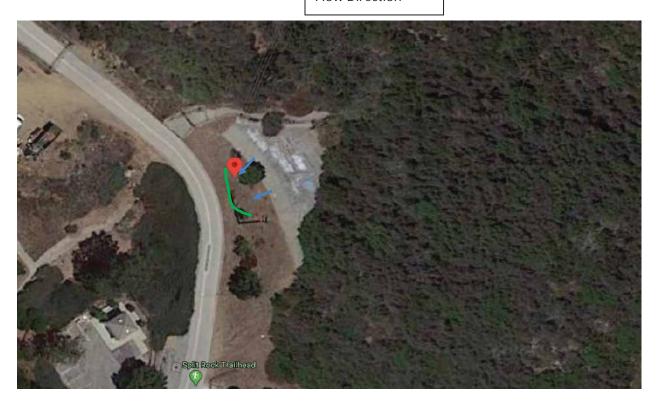
Pole 369211M

Access will be from Water Tank access road off of Via La Costa. No earthwork anticipated
